# **Technical Report:** **March 2008 Groundwater** **Monitoring Program Results and** **Baseline Ecological Risk Assessment**

**Former JCI Stanley Tools Site**  
**Fowlerville, Michigan**

**April 2008**

# SEMI-ANNUAL GROUNDWATER SAMPLING RESULTS REPORT

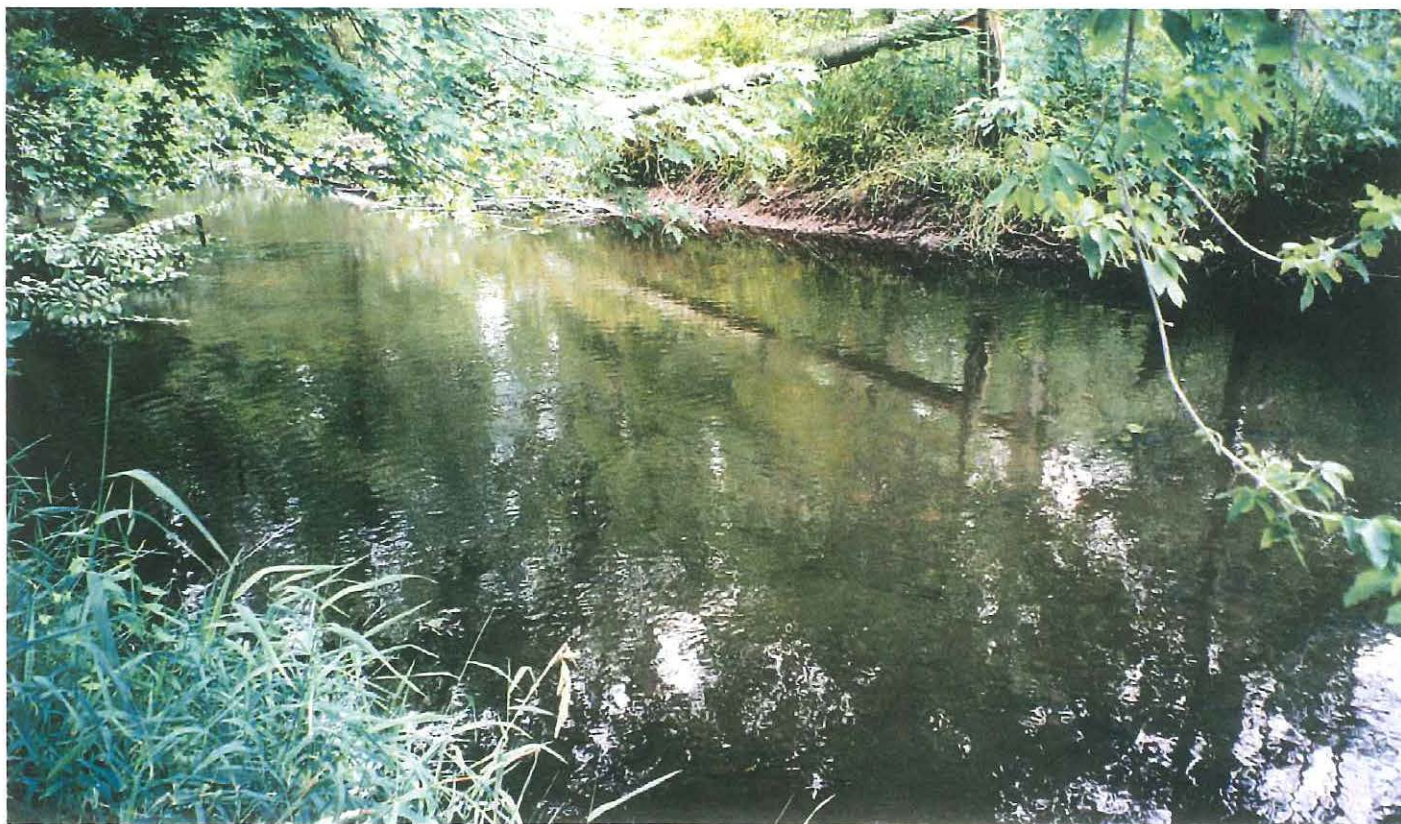
PHOTO 3

SUBJECT: Area of community survey Station 1, approximately 70 feet downstream (N) of sediment sample location SD-J2-001.  
Looking SSW.

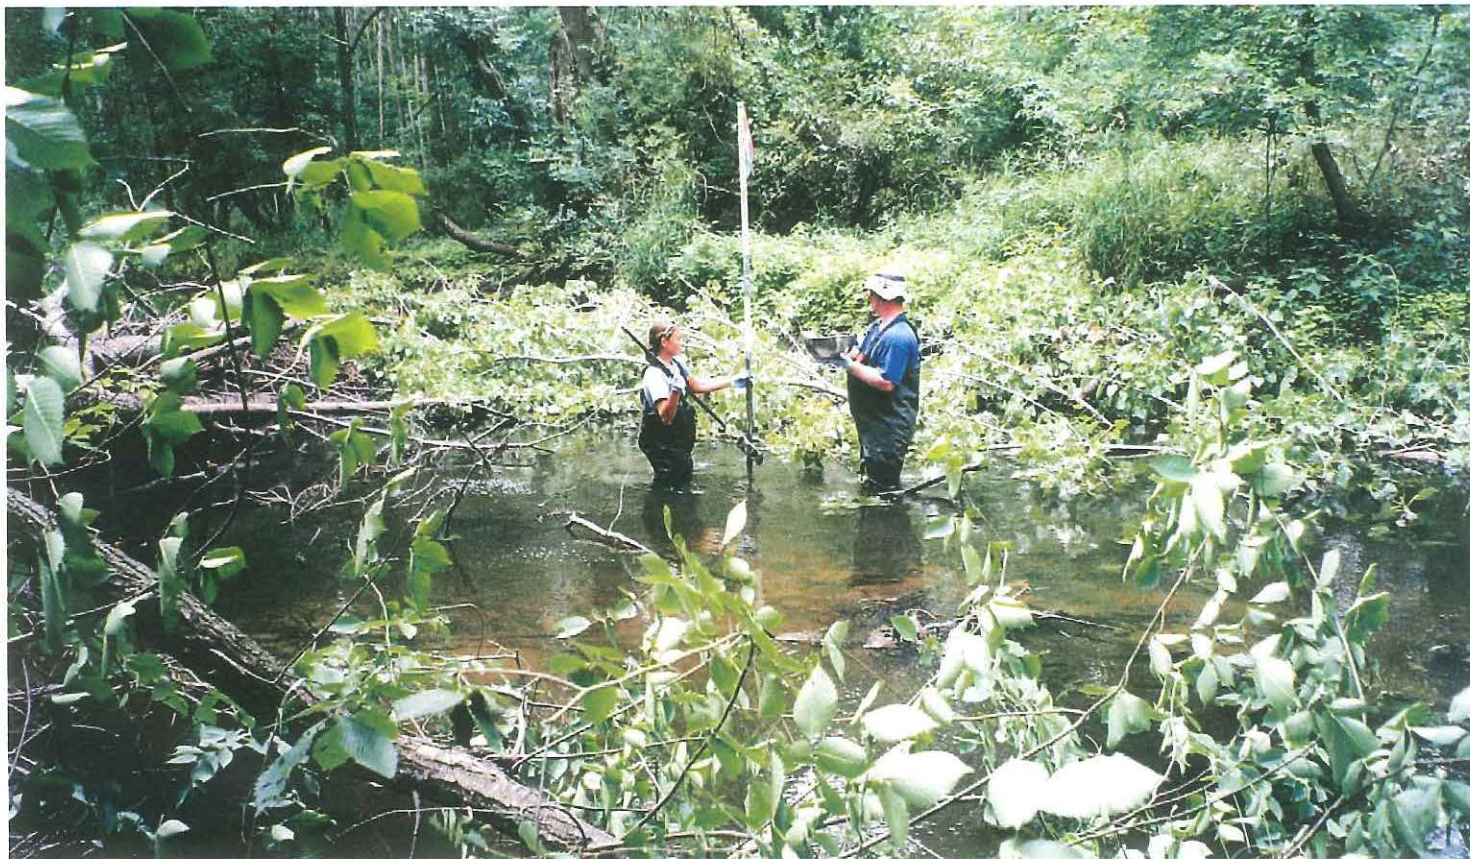
PHOTO 4

SUBJECT: Collecting chemistry/bioassay sample at location SD-J2-001. Looking SW.

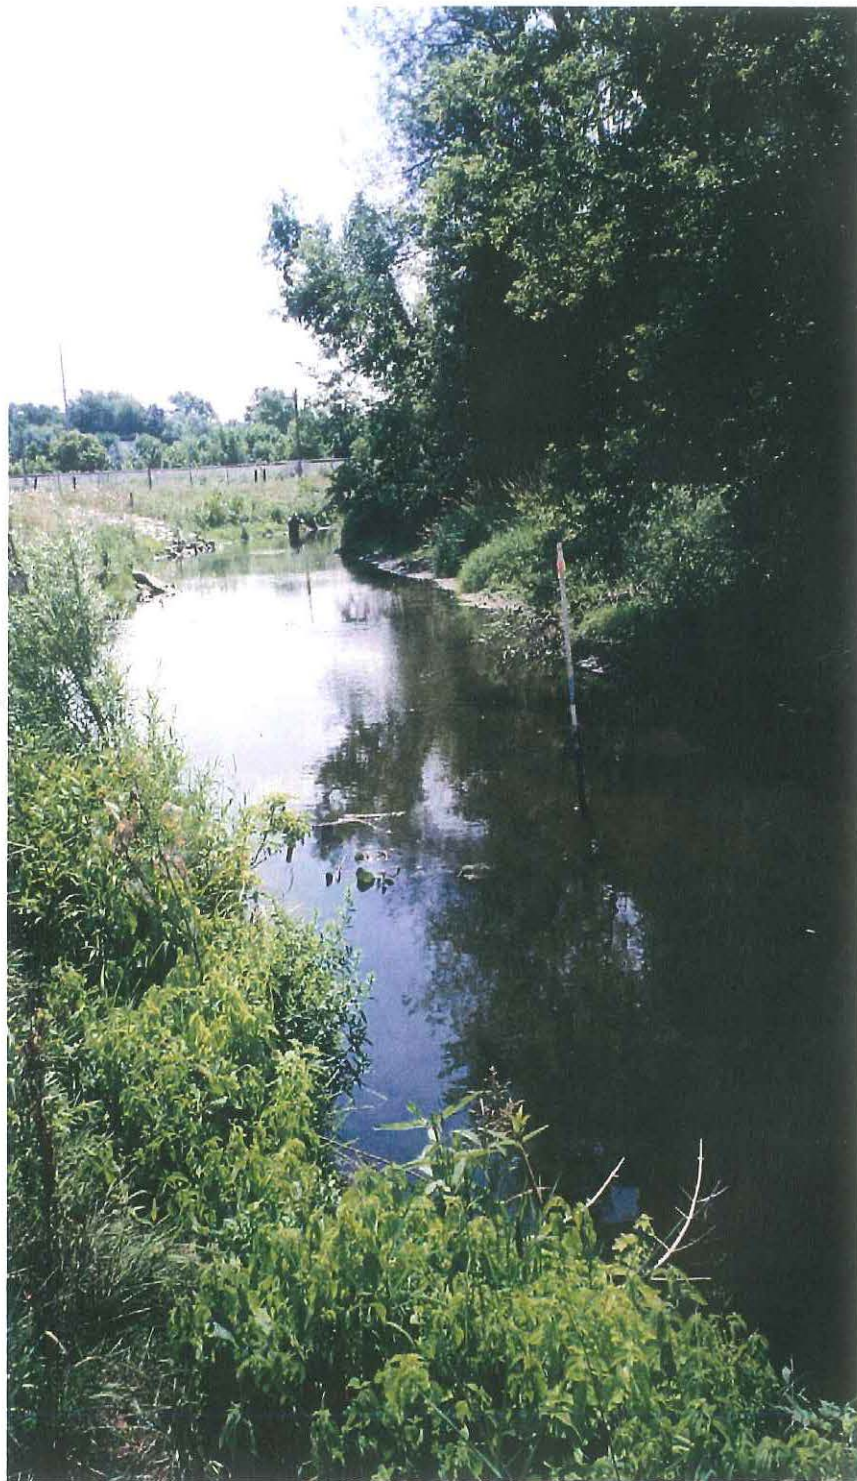
PHOTO 10  
DATE: July 24, 2007  
SUBJECT: Location of sediment sample SD-E3-003. Sampling at SE/RE-3/3-004 occurring in background. Looking S..

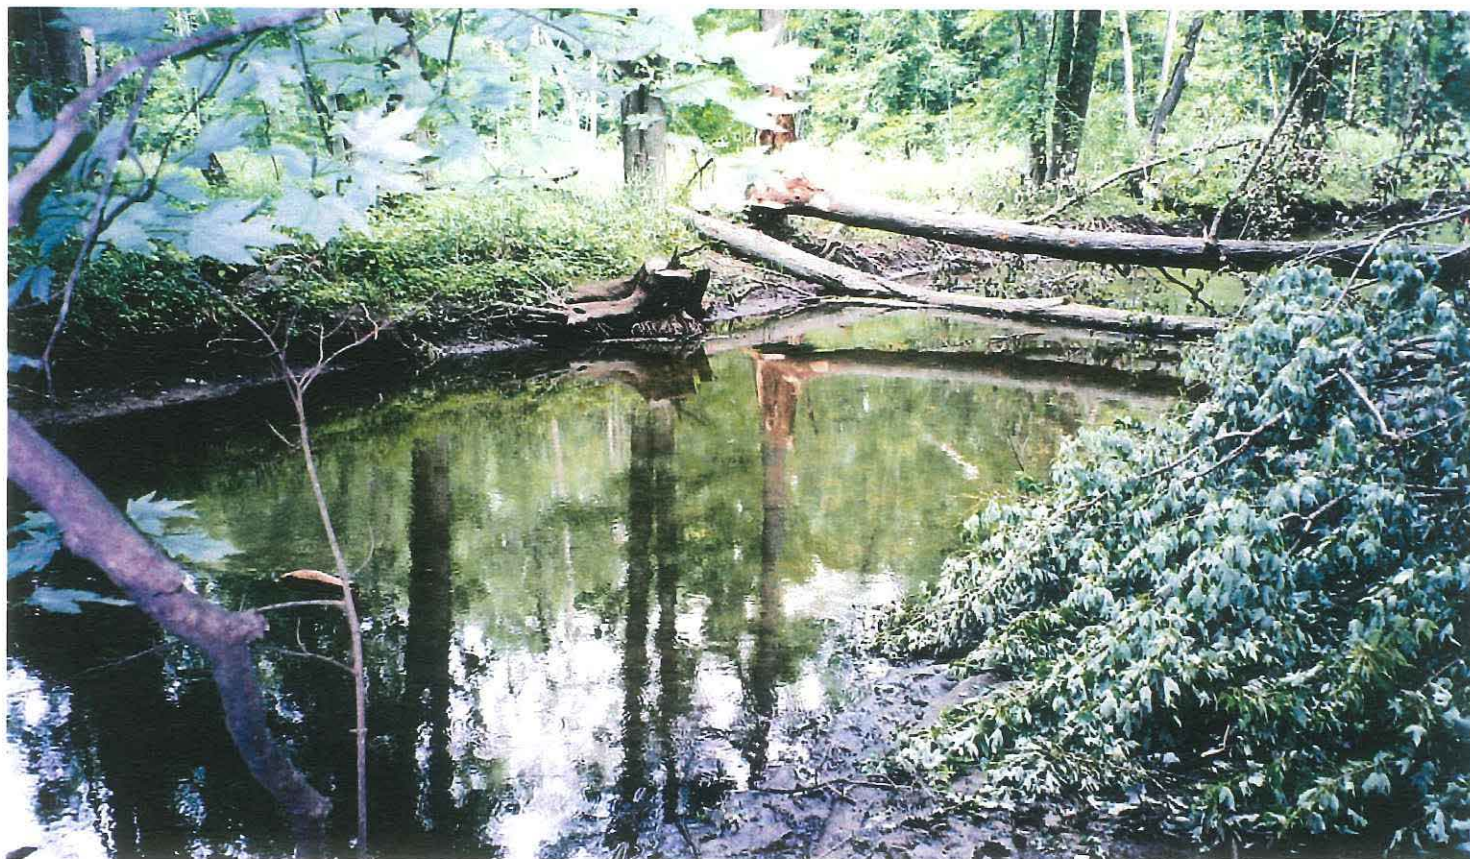
PHOTO 24  
DATE: July 25, 2007  
SITE: Former Stanley Tool Site, Fowlerville, Michigan  
SUBJECT: Community survey Station 07, looking WNW.

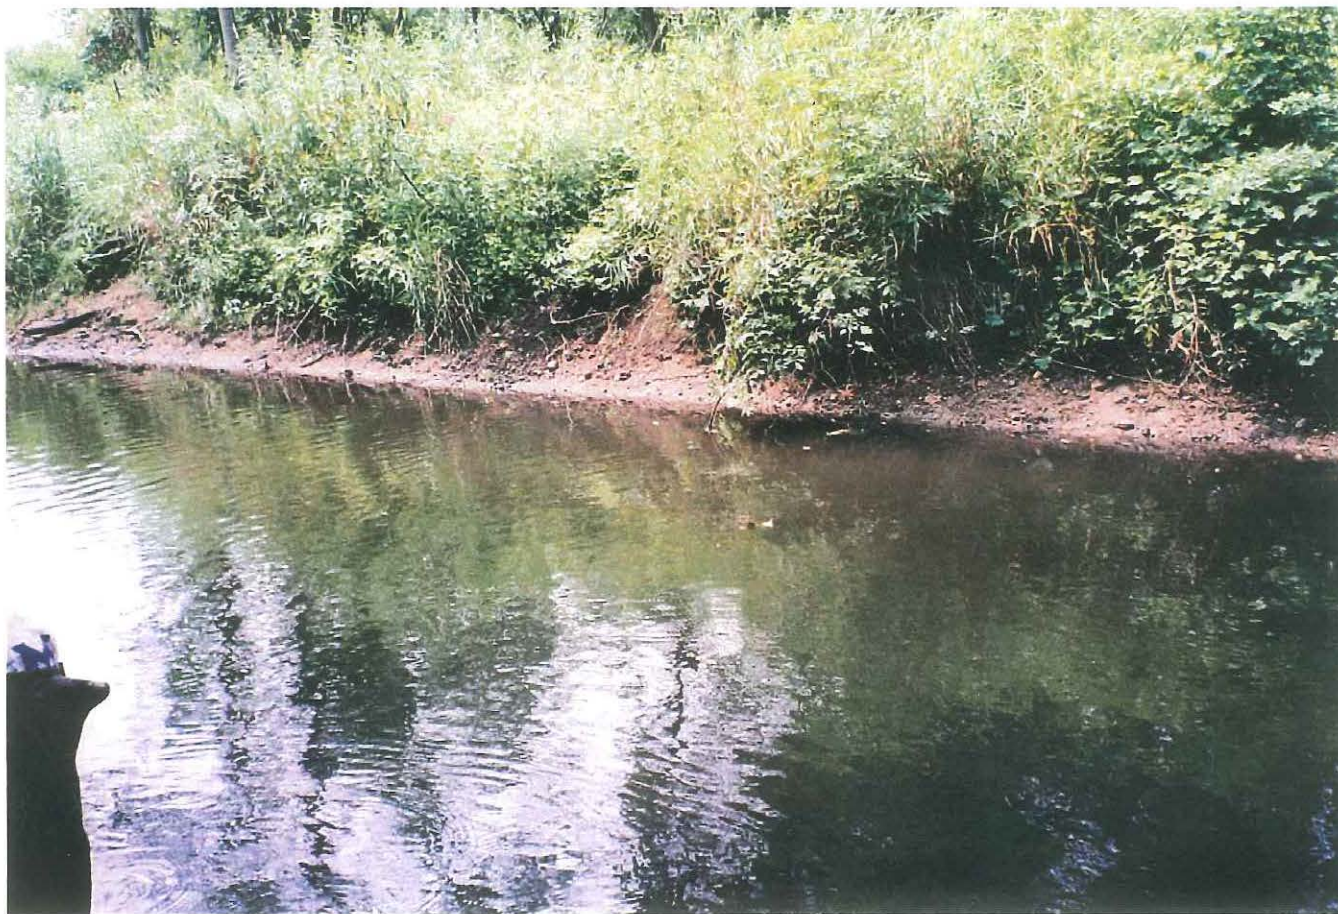
PHOTO 28

SUBJECT: Location of Community Survey Station 08. Looking SW.

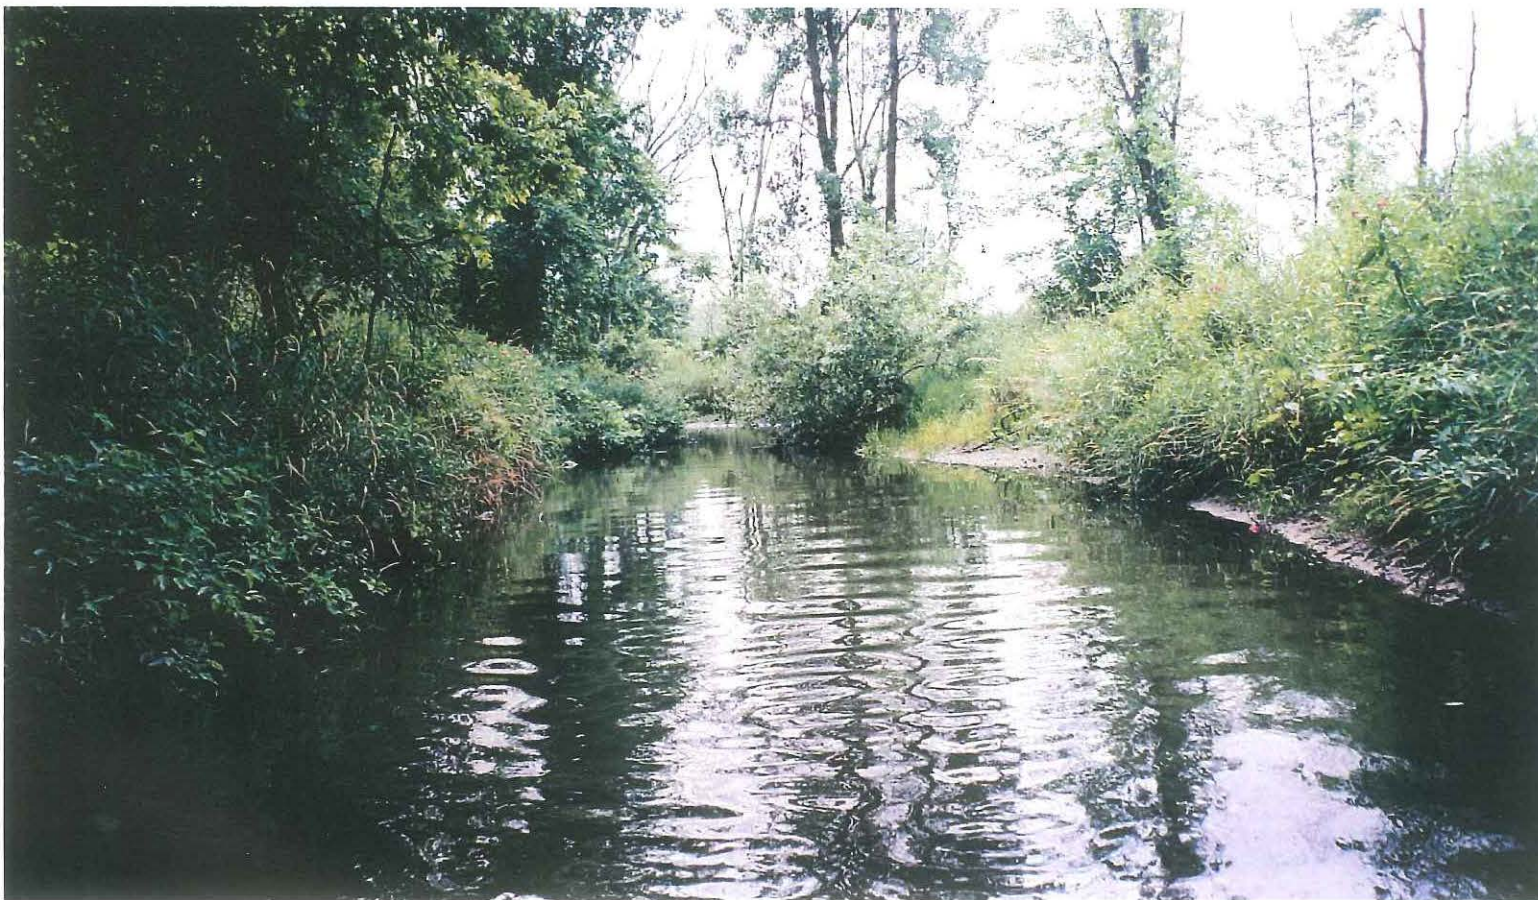
PHOTO 29  
DATE: July 25, 2007  
SITE: Former Stanley Tool Site, Fowlerville, Michigan  
SUBJECT: View of river upstream of Community Survey Station 08. Looking S.

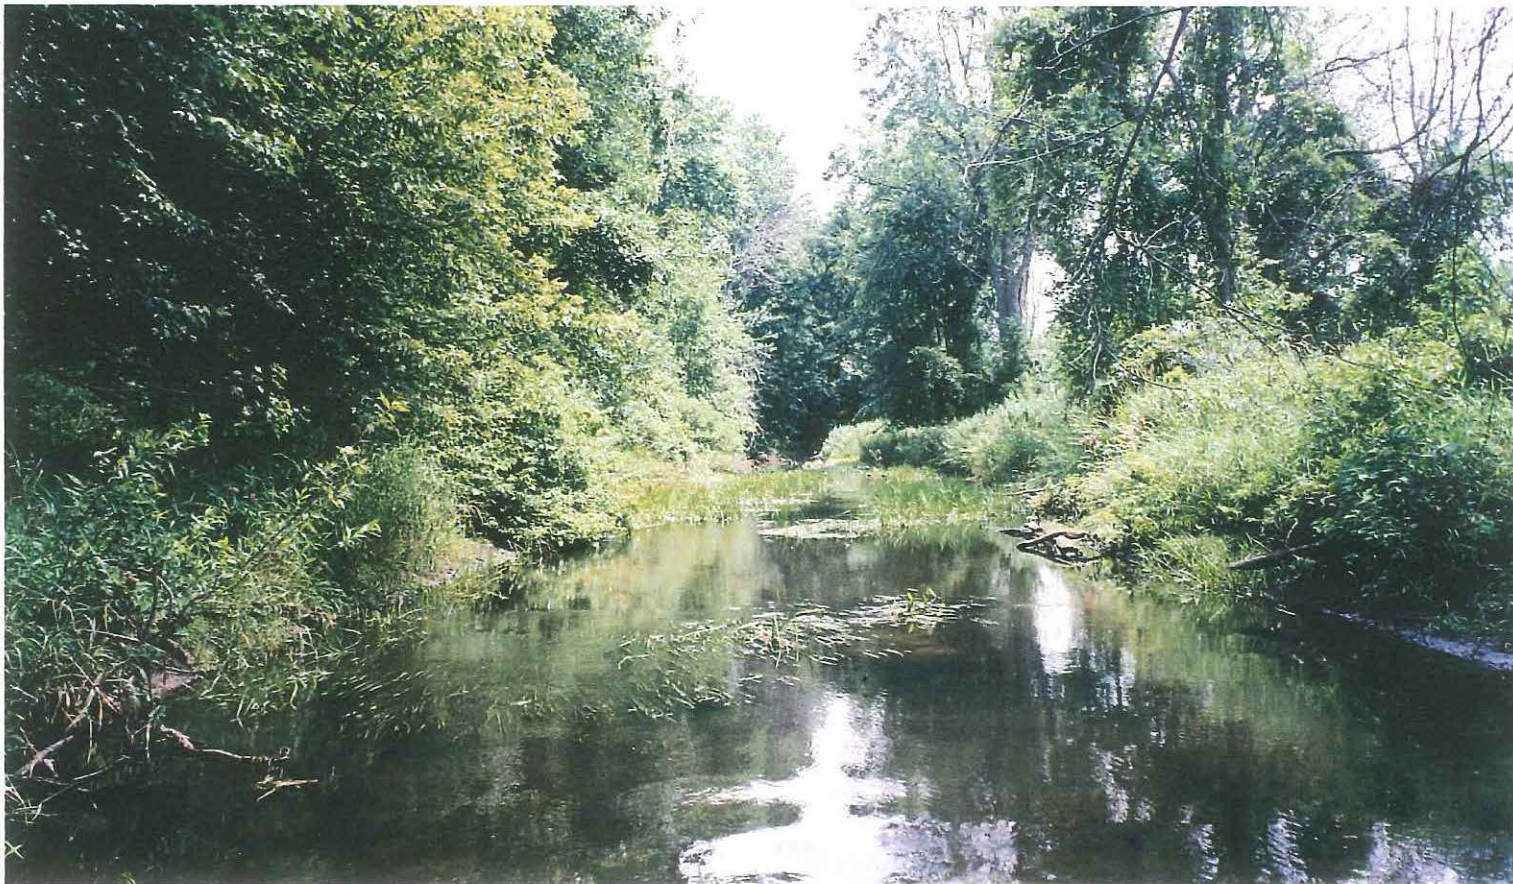
PHOTO 30

SUBJECT: River upstream of Community Survey Station 08 (further upstream from photo 29). Area of shallow riffles and floating and emergent vegetation. Looking ESE

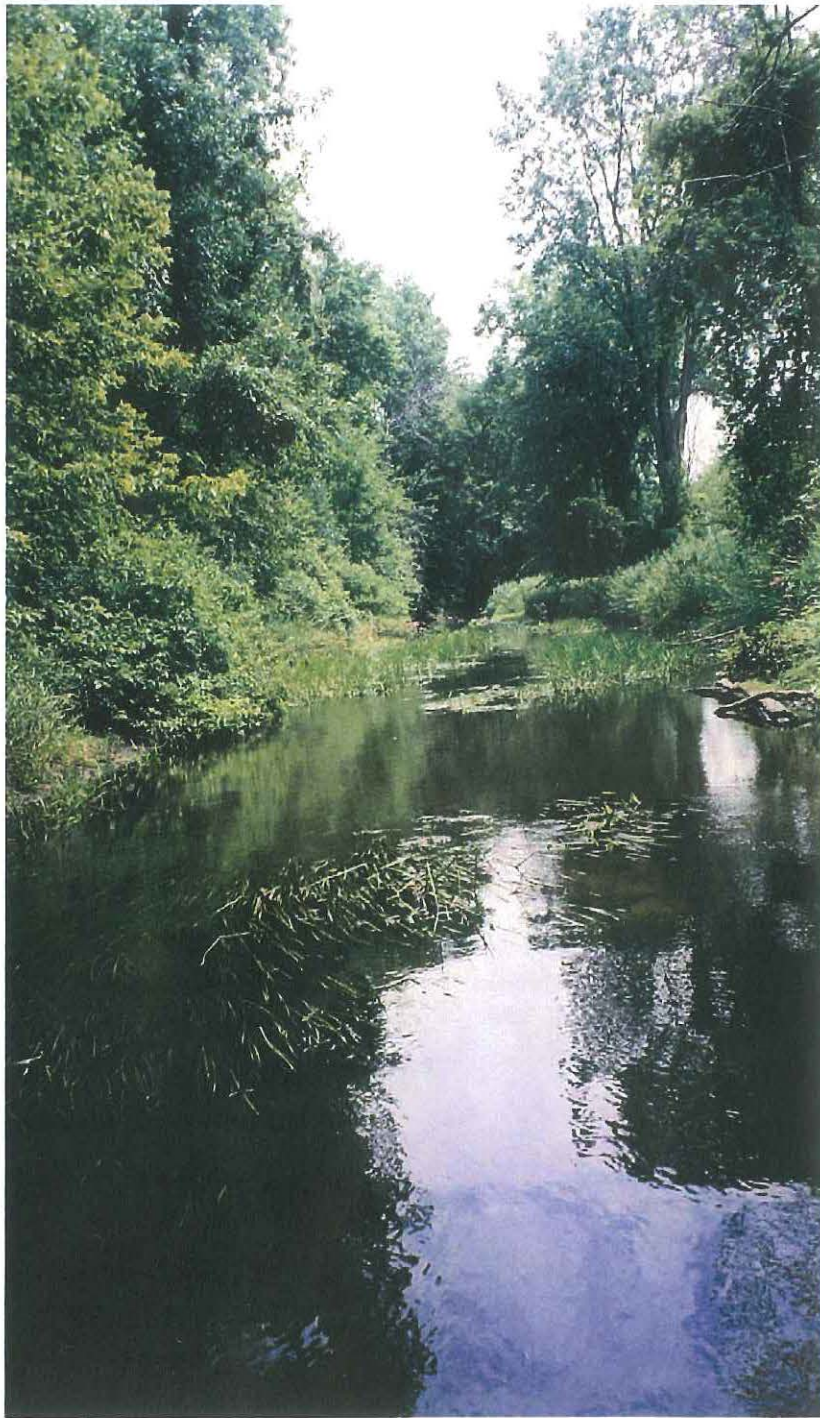
PHOTO 31

SUBJECT: River upstream of Community Survey Station 08 (further upstream from photo 28). Area of shallow riffles and floating and emergent vegetation. Looking ESE

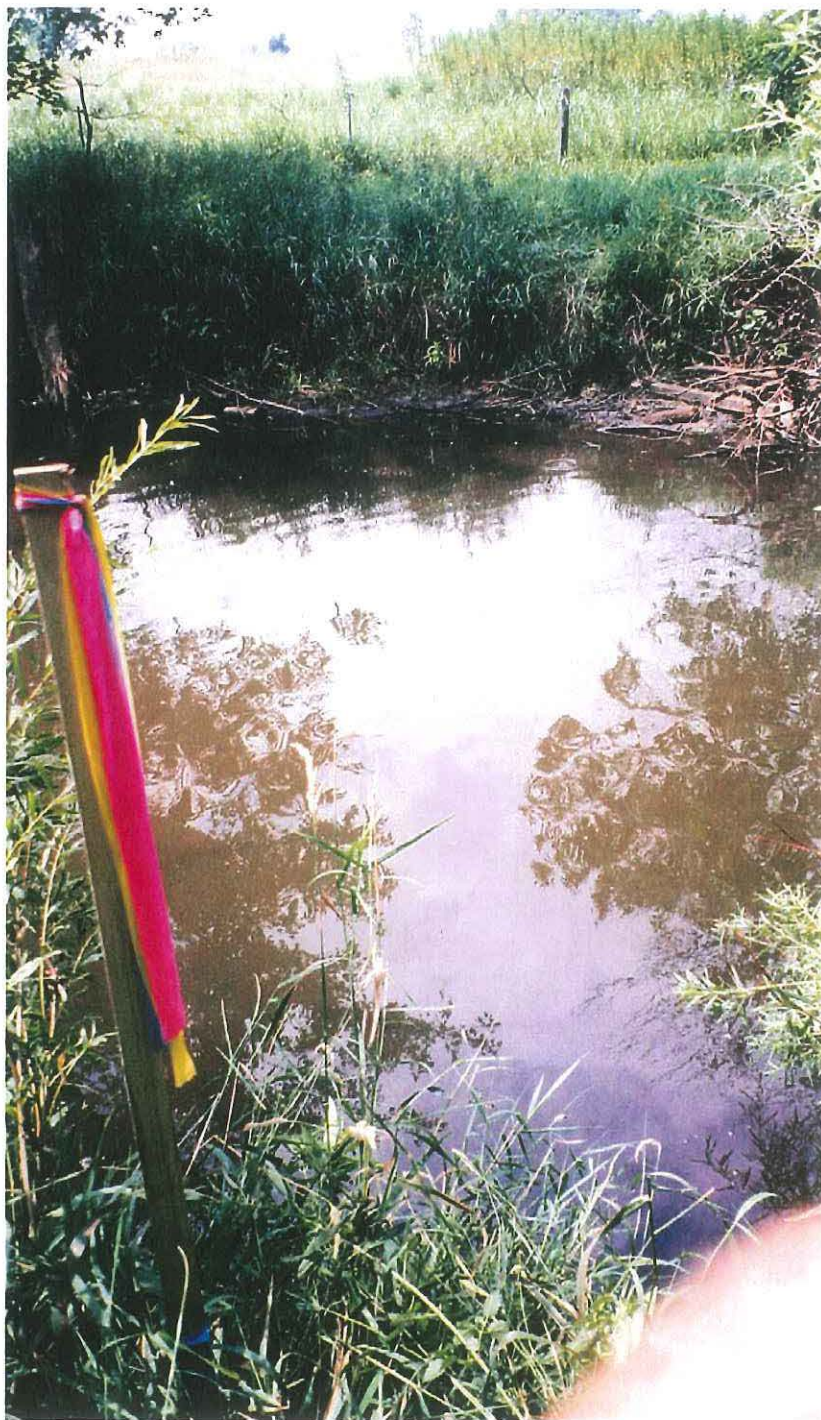
PHOTO 33

SUBJECT: Location of sediment sample SE-RC-13/1-008. Looking W.

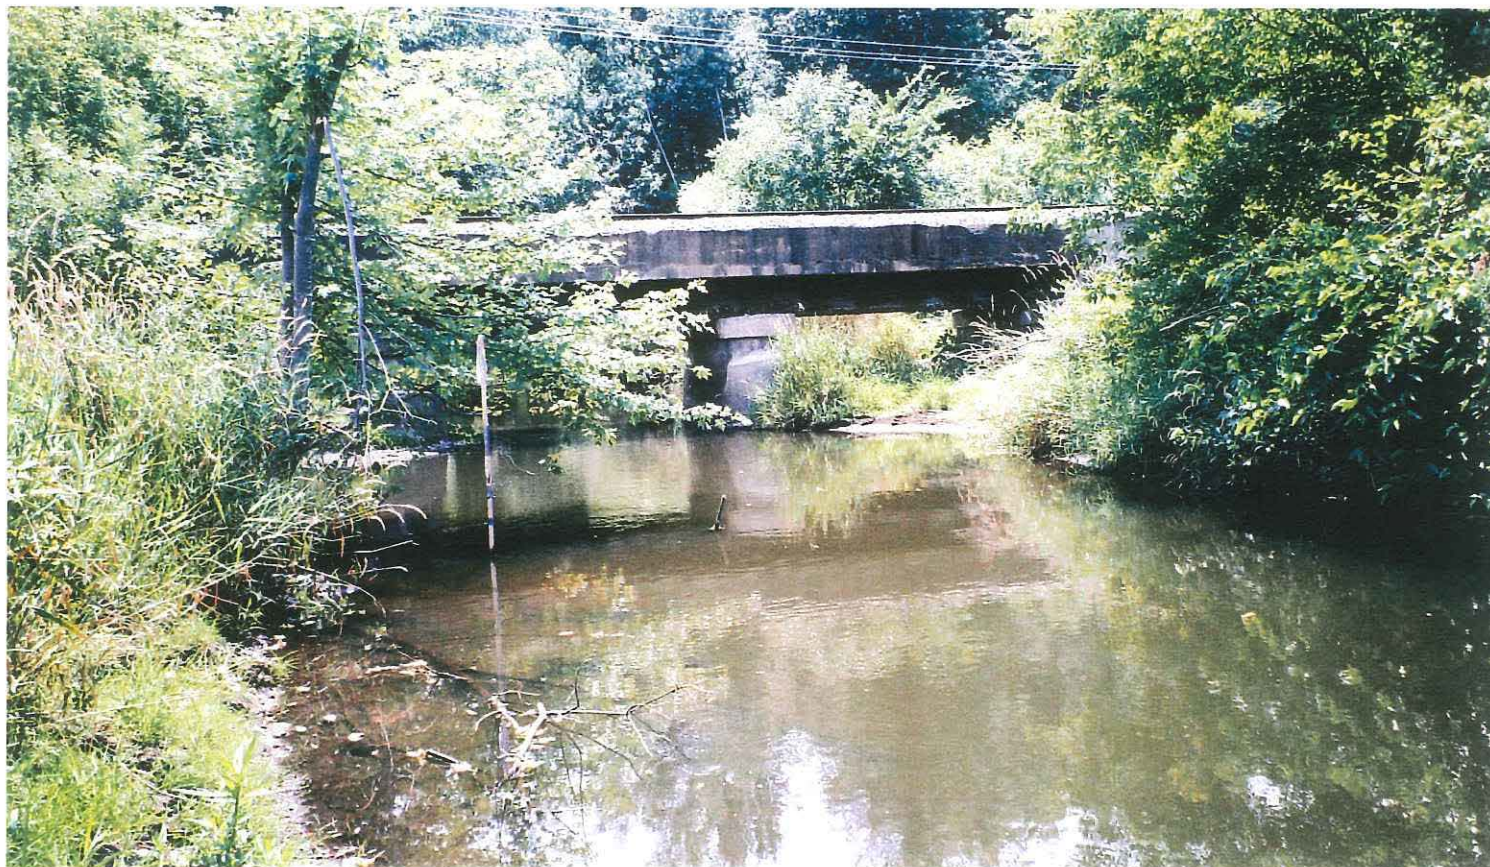
PHOTO 34

SUBJECT: Location of Sediment sample SD-A1-006 near SW corner of the former Stanley site. Community Survey Station 06 placed approximately 40 feet north of sediment sample. Looking SSW.

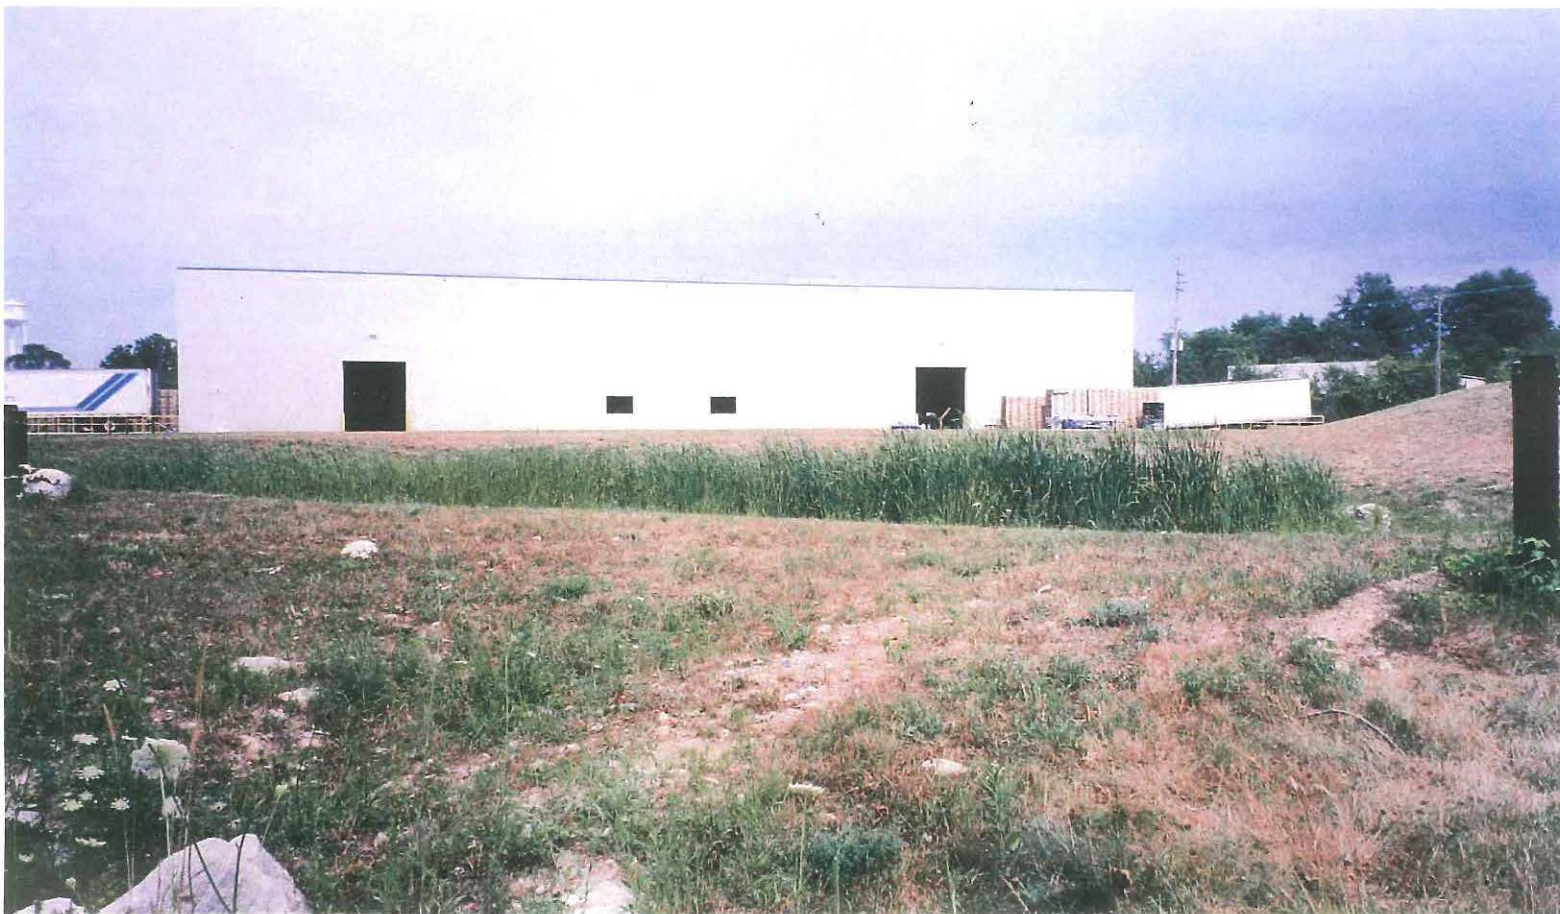
PHOTO 35

SUBJECT: View of former Stanley Site, looking E from river. Wetland area is a low portion of site that drains to the river.

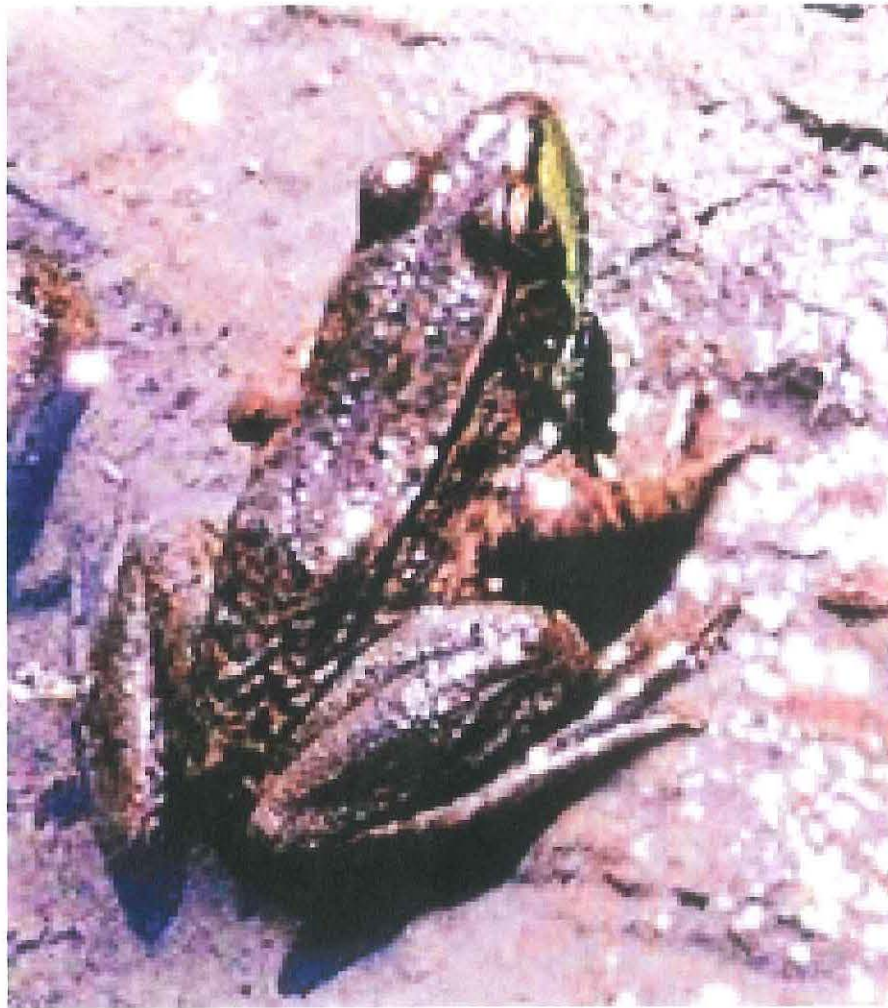
PHOTO 36

SUBJECT: Photograph of wood frog (*Rana sylvatica*) on emergent log along river bank near location of community survey station 04.

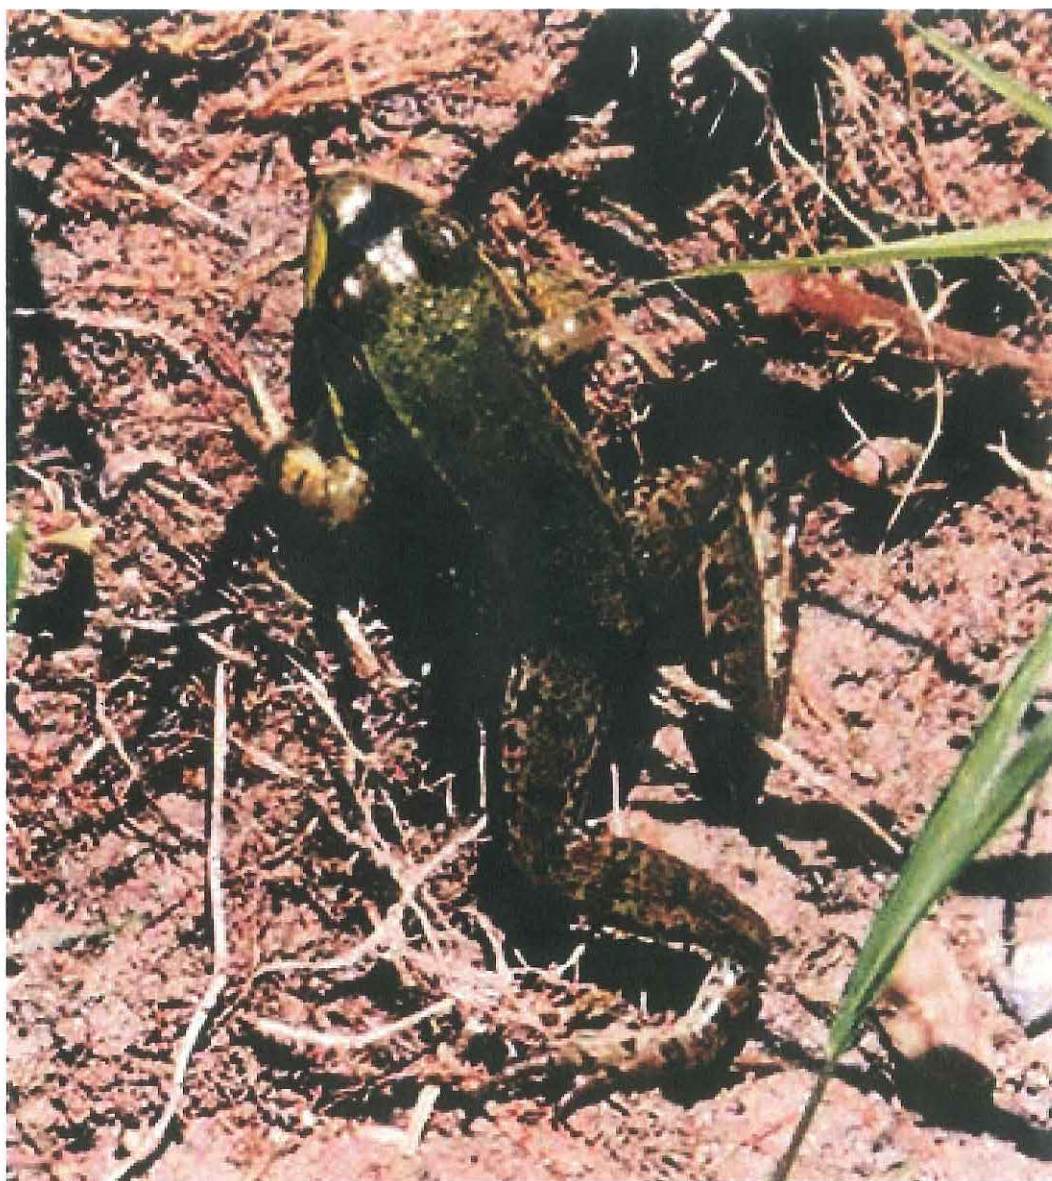
PHOTO 37

SUBJECT: Photograph of leopard frog (*Rana pipiens*) on river bank near  
location of community survey station 04.

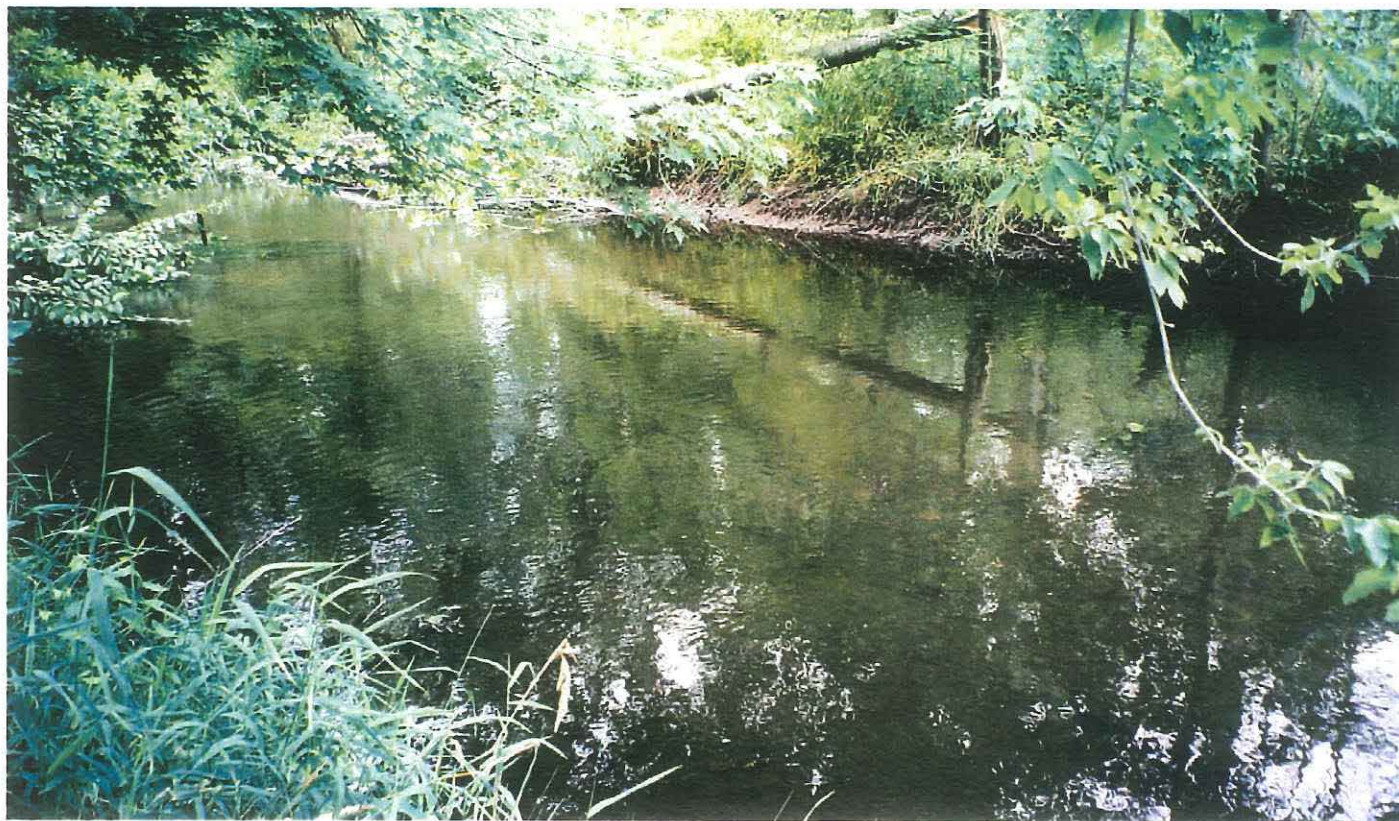
PHOTO 3

SUBJECT: Area of community survey Station 1, approximately 70 feet downstream (N) of sediment sample location SD-J2-001.  
Looking SSW.

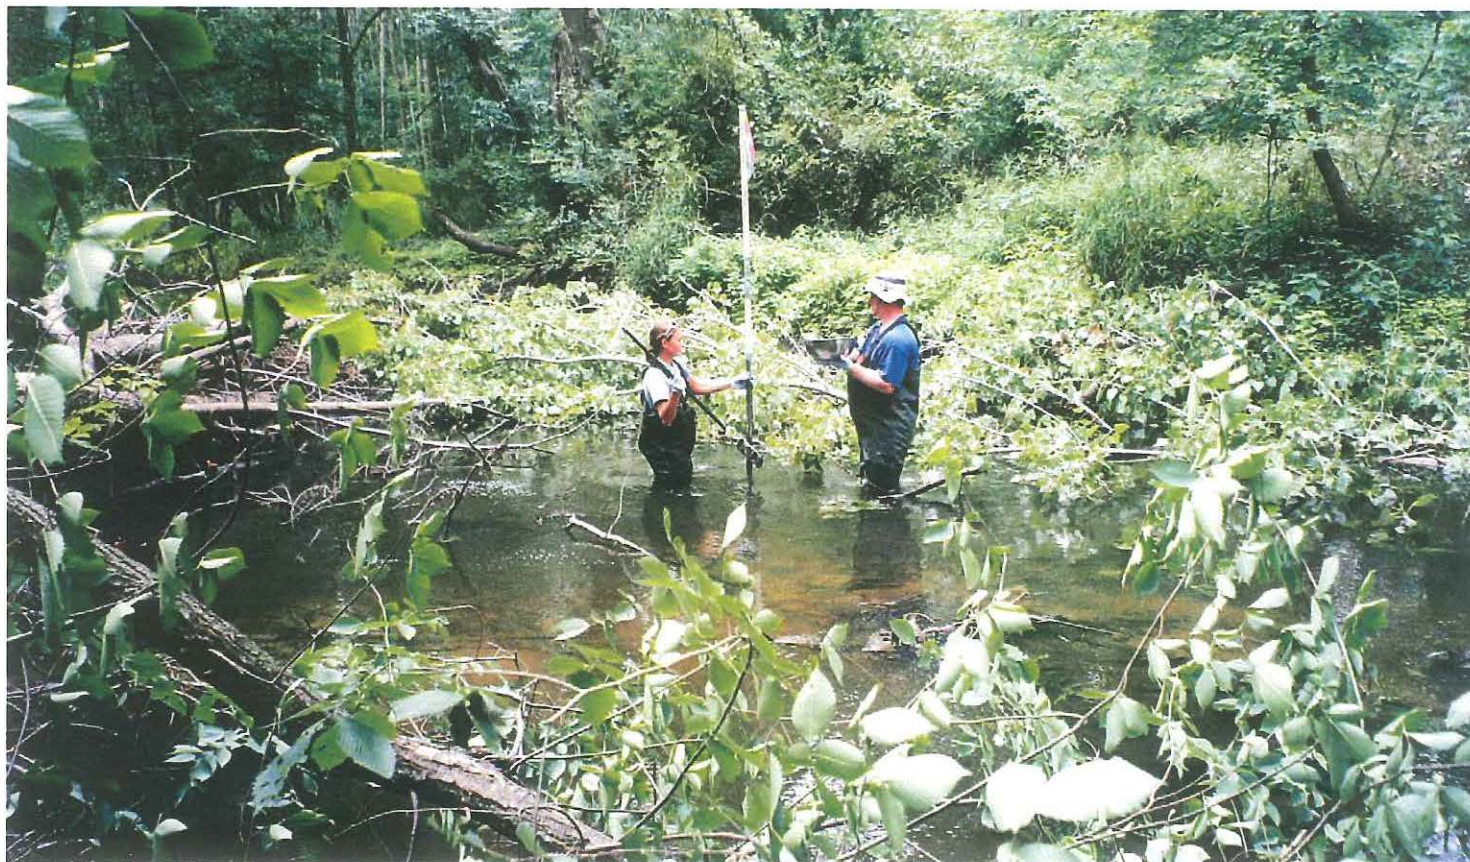
PHOTO 4

SUBJECT: Collecting chemistry/bioassay sample at location SD-J2-001. Looking SW.

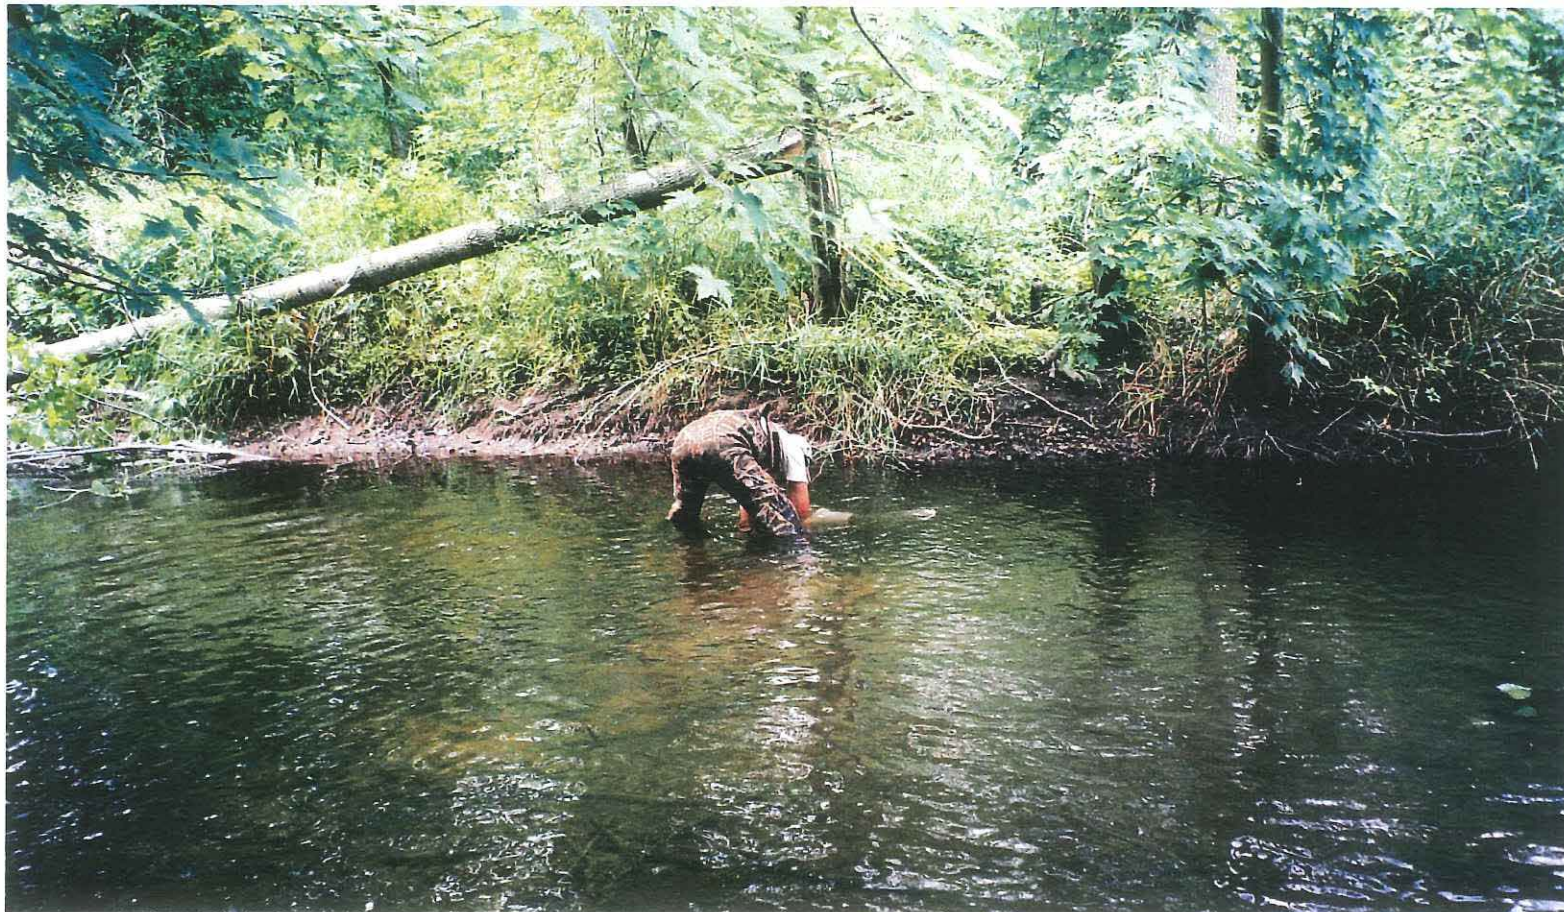
PHOTO 5

SUBJECT: Collecting macro invertebrate sample with Surber sampler at community survey Station 01. Looking W.

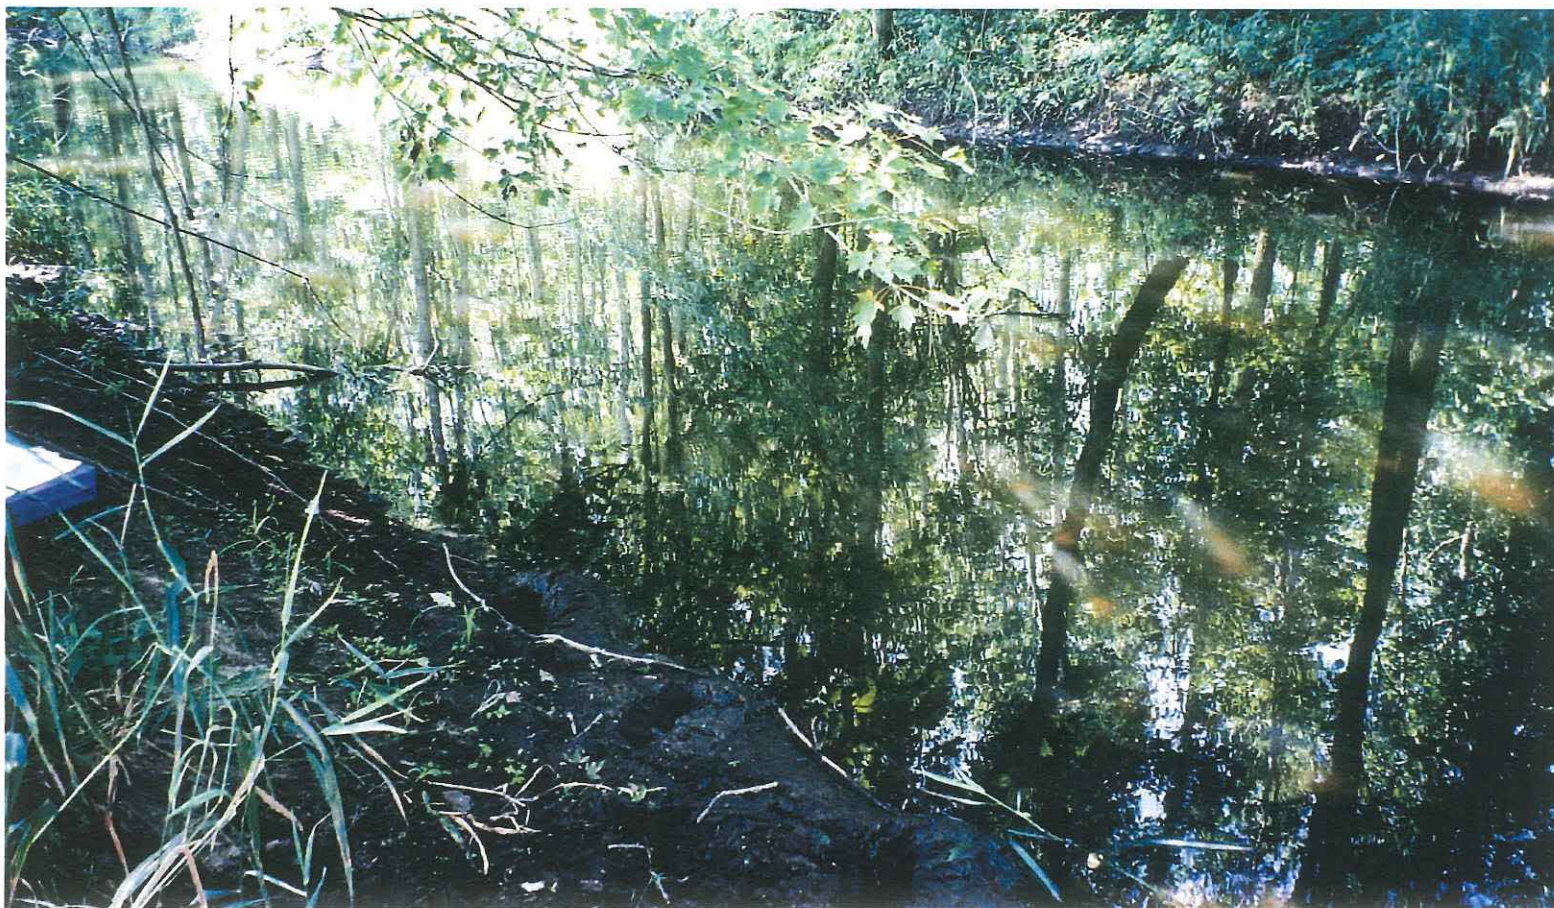
PHOTO 6

SUBJECT: Area of community survey Station 02, approximately 40 feet upstream (S) of sediment sample location SE/RC-9/1-002. Looking SSW.

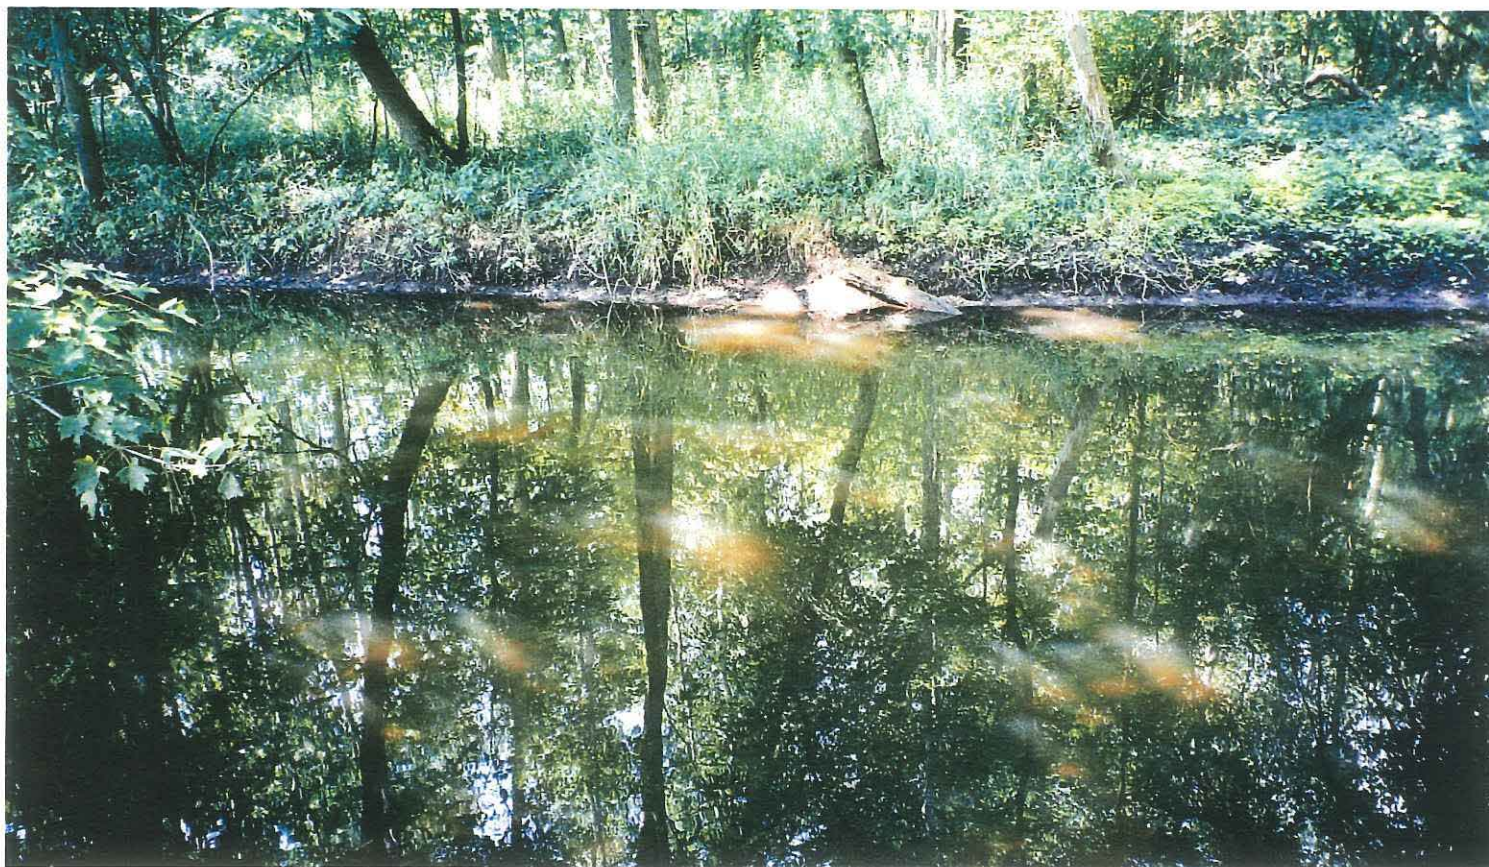
PHOTO 7

SUBJECT: Area of community survey Station 2, approximately 40 feet upstream (S) of sediment sample location SE/RC-9/1-002. Looking W.
